## COATINGS FOR DIRECTIONAL EUTECTICS

FINAL REPORT

J.R. Rairden

1 Report No NASA CR-135050		2. Government Accession No.		3. Recipient's Catalog No.	
4 Title and Subtitle Coatings for Directional Eutectics				5 Report Date July 1976	
				6 Performing Organization Code

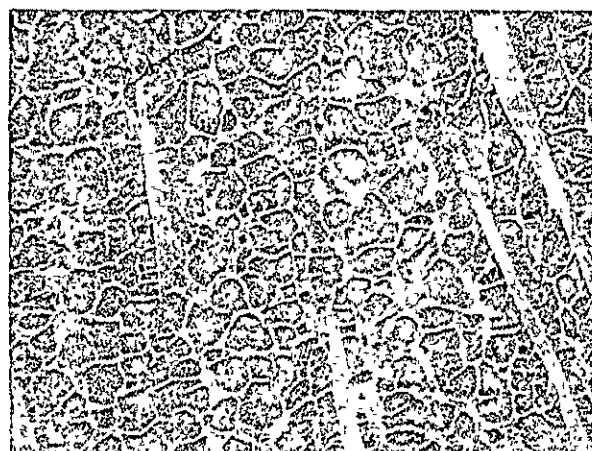
Figure 1. Scanning electron micrographs of as-directionally solidified NiTaC-13: (a) transverse, 620X, (b) transverse, 2580X, (c) longitudinal, 620X, (d) longitudinal, 2580X.

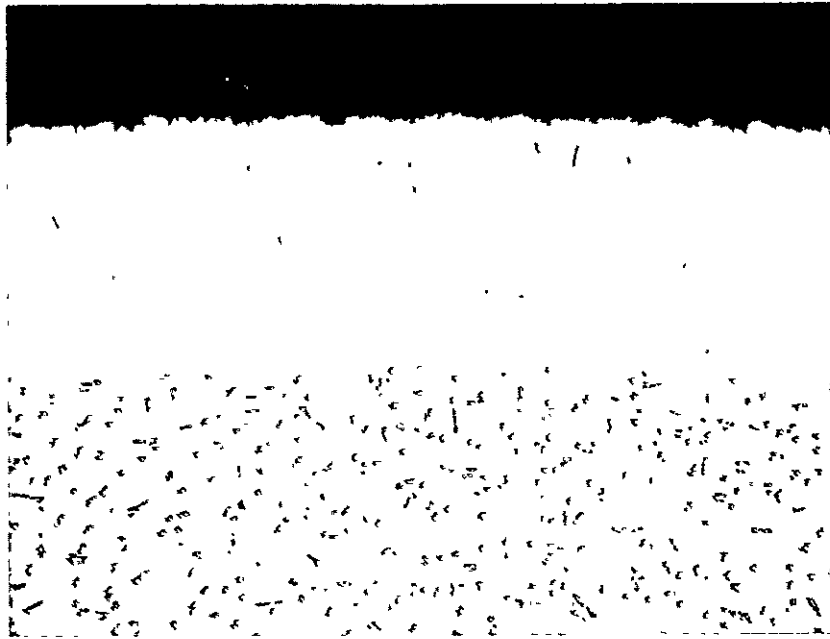
Figure 5. Co-30Cr-5Al-1Y coating E.B. deposited onto NiTaC-13: (a) as-deposited, (b) heat treated 3 hours at 1160°C in Ar. 500X

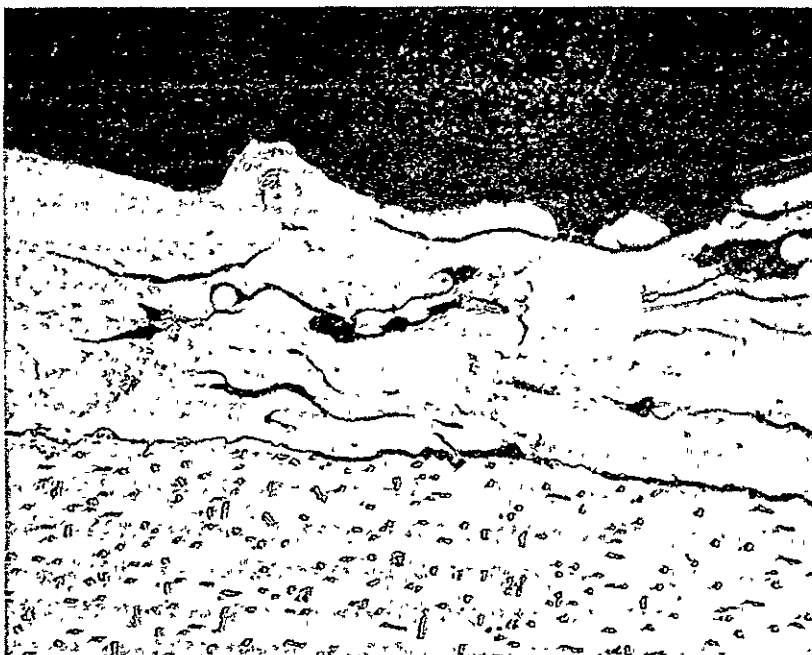
Figure 8. Ni-20Cr-5Al-0.1Y-0.1C coating metal spray deposited onto NiTaC-13: (a) as-deposited, (b) heat treated 3 hours at 1160°C in Ar. 500X

An ingot containing Ni-20Cr-5Al-0.1Y-0.1C was prepared and this was successfully swaged to 0.32-cm-diameter wire suitable for metal spraying. Pin specimens were coated with layers about 50 to 100  $\mu\text{m}$  thick using gun flame to preheat the surface. The coating as deposited is quite nonuniform in thickness and is porous as is shown in figure 8(a). Heat treatment did not densify the coating much, as can be seen in figure 8(b). However, it should be noted that there is very little substrate decarburization which indicates that this concept of carburizing the coating is a valid approach. However, the preheating did result in the formation of a thin oxide layer at the substrate-coating interface. It was considered possible that the denudation resistance might be a result of this oxide layer, rather than the carbon-bearing coating. Therefore, new specimens were prepared without the substrate preheat step. Micrographs of one of these specimens are shown in figure 9 in the as-deposited and as-heat treated conditions. In many regions of this sample, the bond between the coating and substrate was intimate. As before, the tendency toward carbide denudation is essentially eliminated.

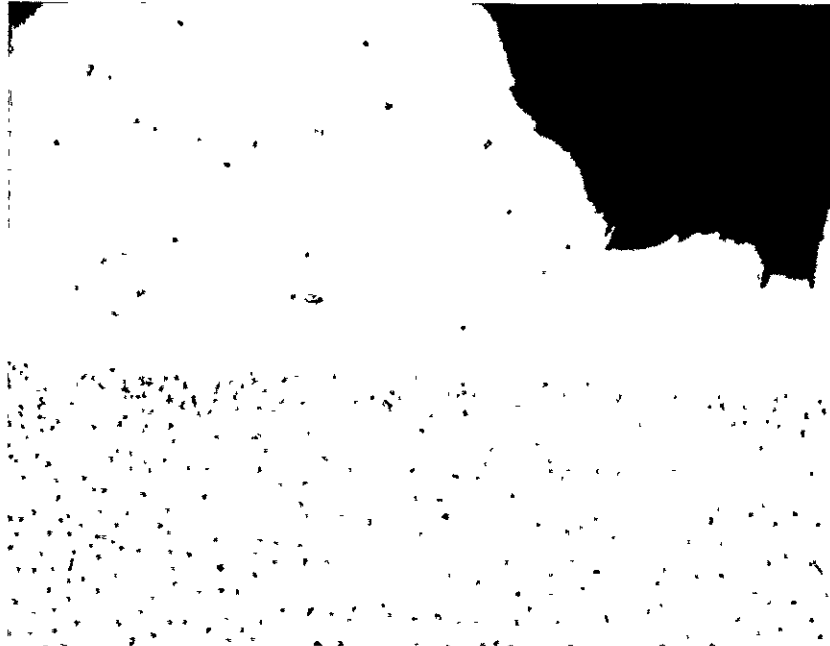
Figure 13. Duplex treated (aluminized) coatings on NiTaC-13: (a) E.B. deposited Ni-20Cr-5Al, (b) E.B. deposited Ni-20Cr-5Al-1Y. 500X

This duplex treatment densifies coatings such as is shown in figure 13(a) for the Ni-20Cr-5Al. There is a region of a predominantly white phase (probably high Cr) about 25 to 50  $\mu\text{m}$  from the surface of Ni-20Cr-5Al. A similar region is found in the duplexed Ni-20Cr-5Al-1Y coating as can be seen in figure 13(b).

Figure 13(d) is the duplexed Co-30Cr-5Al-1Y coating. Very little white phase precipitate is observed in this coating.

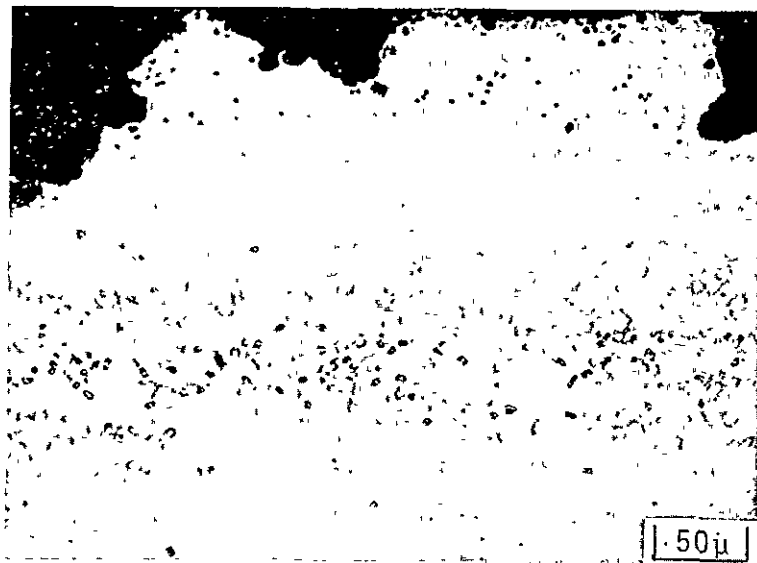
Figure 17. E.B. Co-30Cr-5Al-1Y+aluminize on NiTaC-13 after 2000 hours cyclic oxidation (1100°-93° C).

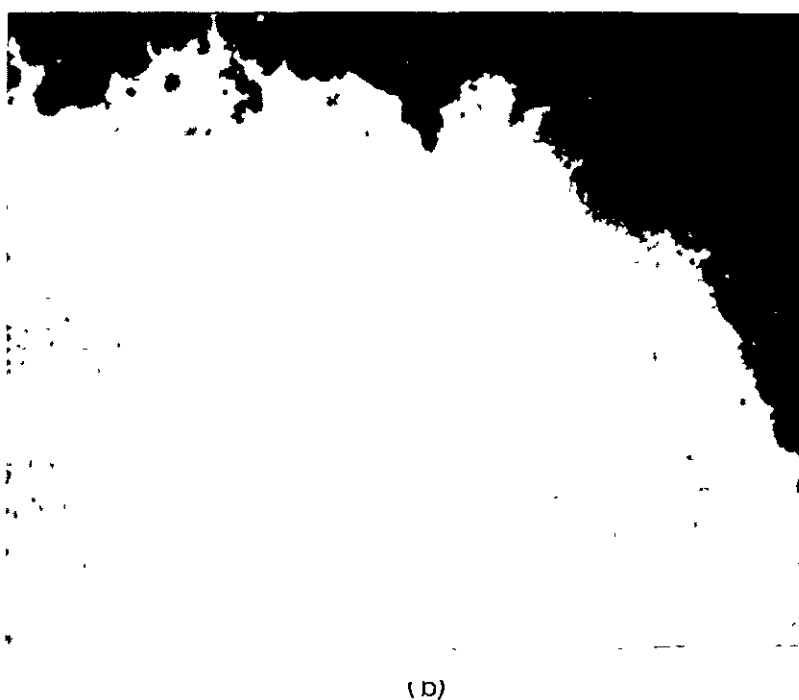
Figure 38. Longitudinal sections through NiTaC-13 bars coated with Ni-20Cr-5Al-0.1Y-0.1C+Al rupture tested at 871°C, 434 MN/m<sup>2</sup> in air after 1100°C cyclic oxidation for (a) 148 hours and (b) 360 hours. 500X

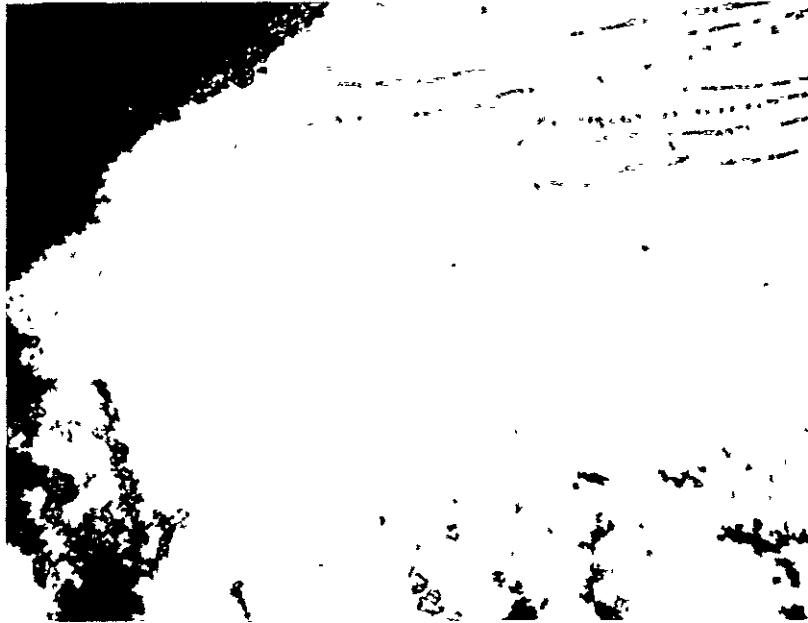
Figure 40. Longitudinal sections through NiTaC-13 bars coated with Ni-20Cr-5Al+Al rupture tested at 871°C, 434 MN/m<sup>2</sup> in air after 1100°C cyclic oxidation for (a) 148 hours and (b) 360 hours. 500X

A similar series of micrographs of the fracture is shown in figures 40 and 41 for bars coated with Ni-20Cr-5Al+Al. Again, microstructures are as expected from pins cycled much longer times. Excellent bonding of coating and substrate was noted in all samples, with no indication of delamination of the preferred coatings. Little fiber loss is noted after 360 hours of
